**ACME POND DAM
CT 00172**

**PHASE 1 INSPECTION REPORT
NATIONAL DAM INSPECTION PROGRAM**

**DEPARTMENT OF THE ARMY
NEW ENGLAND DIVISION, CORPS OF ENGINEERS
WALTHAM, MASS.**

MARCH 1981

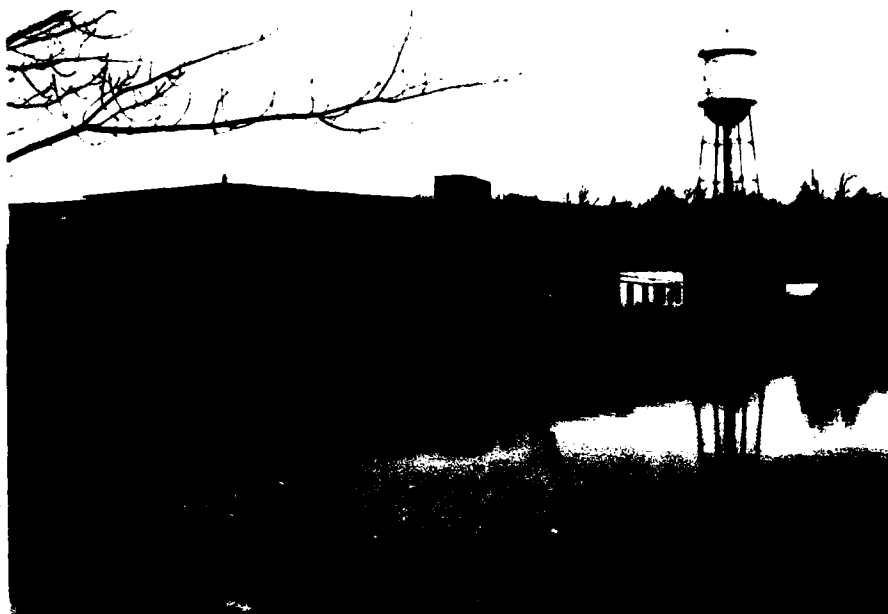
Photos 1 & 2. View of upstream side of dam as seen from left abutment. Note stone wall near left abutment and large riprap to the right of the dam. Spillway is at far right.

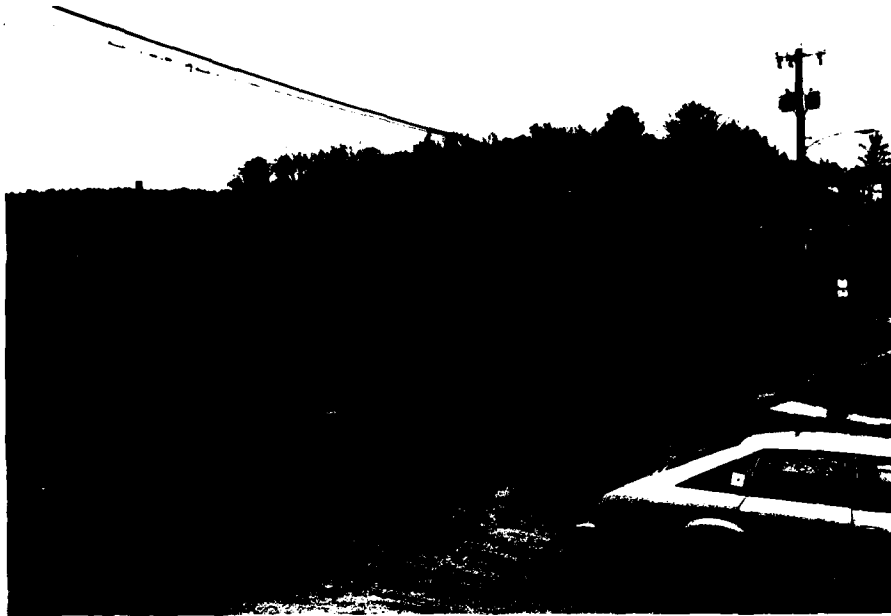
3. Downstream slope: The downstream stone masonry wall is the full height of the dam in the vicinity of the spillway and outlet structure and is about 7 feet lower than the dam elsewhere (Photos 3 and 4). The downstream stone wall has tilted in several areas, particularly near the right abutment (Photos 5 and 6). Because of the excessive tilting, the joints opened up as shown in Photo 6. It should be noted that the bulging of the downstream walls was first observed some time ago, as noted in the inspection report of William W. Pike in 1954. Apparently because of this report, a section of the downstream wall was repaired with a concrete wall left of the spillway (Photo 3). The concrete wall has no drainage holes. The remaining downstream slope above the wall is irregular and its inclination ranges from 1.5H:1.0V to 2.0H:1.0V. The slope has some growth of bushes and saplings. No seepage was observed on the downstream slope nor at the toe. A masonry stairway is built into the stone wall just south of the intake structure (See Site Plan and Photo 10). Immediately south of the stairway, the stone wall bulges as shown in Photo 10. Towards the left abutment several bedrock outcroppings were observed at the toe of the stone masonry wall. Indications are that this section of the dam is resting on bedrock. No seepage was noted on the left side of the dam.

Photo 3. Downstream wall of dam and spillway. Note reinforced concrete wall installed to the left of the spillway.

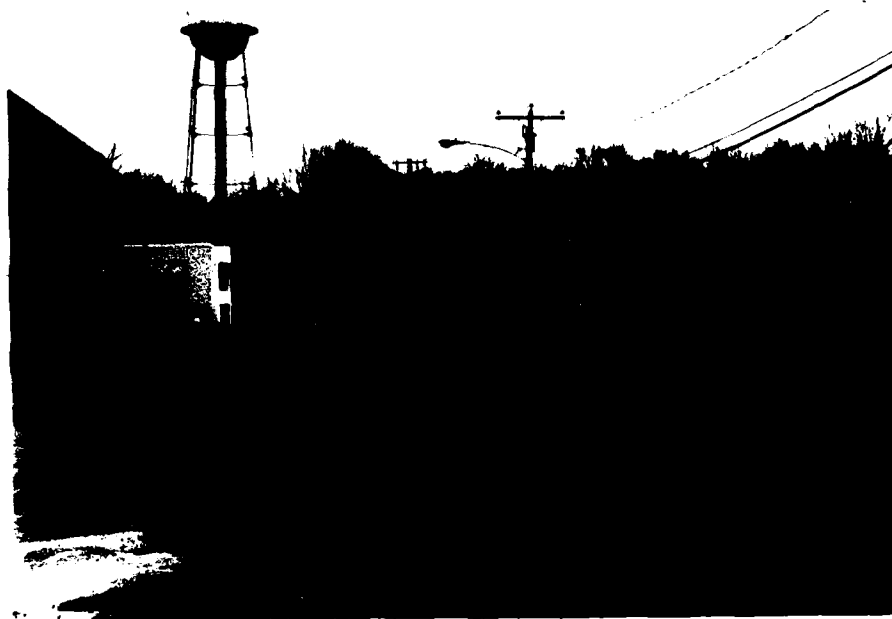
Photo 4. Overall view of downstream wall and slope.
